CASE STUDY

MP1000 COUNTERWEIGHT ASSEMBLY REPAIR / UPGRADE

LOCATION	Western Australia, Australia.
TYPE	Gold Mine
APPLICATION	Metso MP1000 Counterweight Assembly

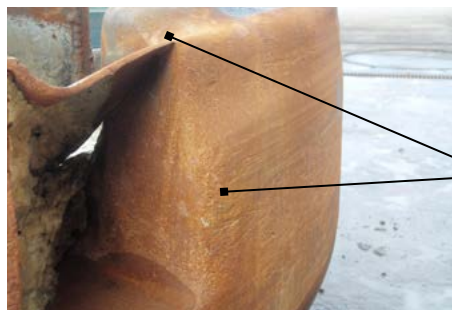
At a Western Australian gold mine the customer had an ongoing issue with the counterweight assemblies within their MP1000 crushers, not lasting to scheduled manganese liner change-outs. This was attributed to the top guard wearing through, causing excessive wear to the counterweight sub-assembly. The counterweight then became unbalanced, leading to excessive vibrations within the crusher. Our client was then forced into shutdown mode on a breakdown basis to get the counterweight assembly immediately changed out.

Counterweight sub assembly damage

In addition to the repair and static rebalancing of the counterweight; H-E Parts recommended that the customer have both the top guard and outer guard manufactured with H-E Parts Protech™ PT-650 wear plate, which has superior wear and impact resistance in comparison to the original 400 Brinell Q&T plate. In consultation with H-E Parts in-house engineering department, our off-site repairs team then custom-fabricated and installed the PT-650 fitted counterweight guards at our Perth facility.
