CASE STUDY

UNIQUE APPROACH TO PLANT UPGRADE

At a sand load out station located near the mouth of the Brisbane River in Queensland, H-E Parts was invited to submit a construction proposal for the replacement and removal of a rusted and damaged sand bin along with three rusted gangways.

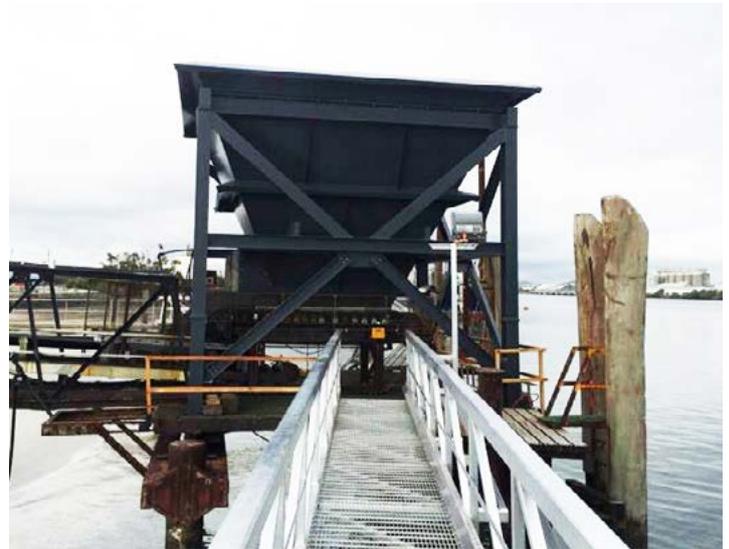
Rusted & damaged sand hopper

Rusted gangways

H-E Parts successfully completed the scope of work, which was to remove and replace with new – one sand bin and three aluminum gangways, totaling 55 meters in length. We mobilized a 250-ton crane onto a large dumb barge and towed it into position alongside the wharf using tug boats. All original equipment was removed from the site and disposed of and the project was completed on time and on budget. The methodology of using cranes and barges made the job quite unique and provided a cost-effective solution for the customer.
