# CASE STUDY

## KODIAK K300+ CONE CRUSHER LINER SUCCESS

LOCATION	Hanson Kulnura
MINE TYPE	Basalt Quarry
APPLICATION	Kodiak K300+ Cone Crusher

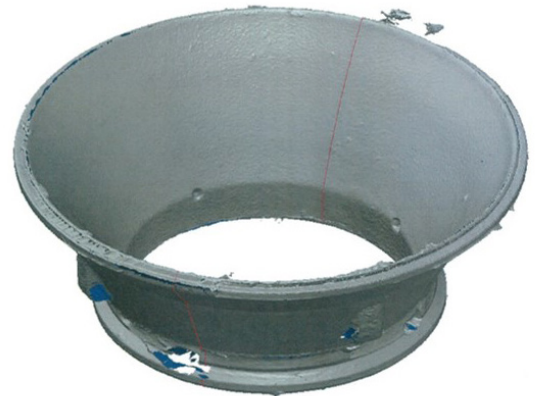
3D scanned worn OEM liners

To facilitate a customized liner design, a H-E Parts engineer traveled to Kulnura to conduct 3D laser scanning of OEM supplied new and worn crusher liners. These scans were then used in conjunction with H-E Parts proprietary ChamberVision™ and CrusherVision™ software, allowing H-E Parts dedicated engineering specialists to offer a solution to extend liner life and reduce total cost of ownership. Following an analysis of the OEM supplied liner profiles, a new set of liner profiles were offered to the customer that:

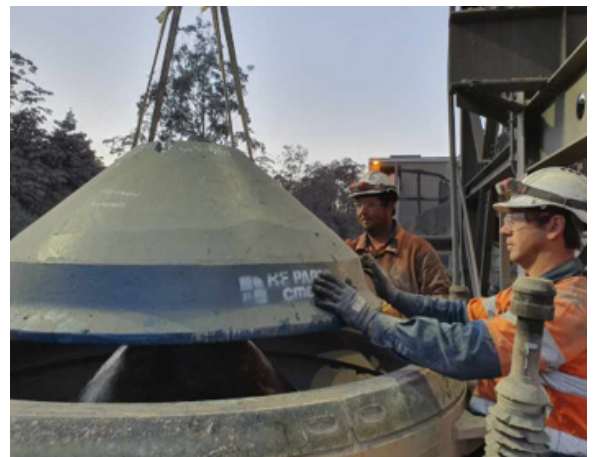
Optimized CME™ MnElite liners being installed

- Increased liner life by better utilizing the adjustment parameters of the crusher and ensuring optimum material utilization
- Improved inter-particle crushing and promote liner ‘work hardening’ by reducing nip angles throughout the active crushing zone of the chamber, which allows for increased surface pressure and reduced material slippage and gouging
- Prevented the formation of ‘hooking’ at discharge ends by adjusting bowl and liner discharge profiles to better maintain alignment of the liners as they wear down

The proposed liner profiles were adopted and ran successfully by Kulnura with no issues on the very first set provided. The liners were removed from production at 15 weeks, far surpassing the OEM supplied liners which had a historic average of 5 weeks. In addition, the liners still had 60mm (2.4”) of wear remaining, with H-E Parts engineering team confident that these liners can be run down to 20mm (0.8”), this represents approximately another 5 weeks of available life remaining.
