CASE STUDY

CAT 793D SERVICE ISSUE IDENTIFICATION

LOCATION	Western Australia, Australia
APPLICATION	CAT 793D
PRODUCT	COR Cooling™ radiator

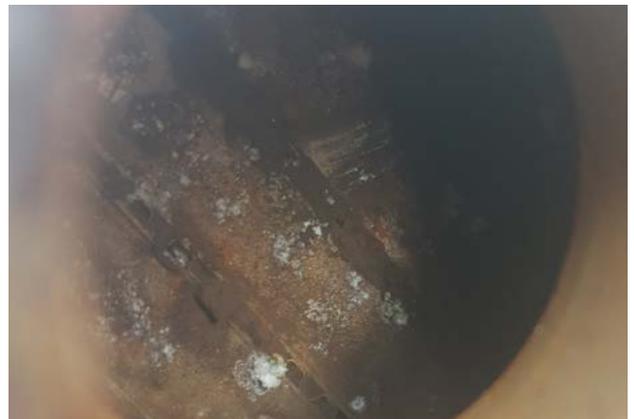
H-E Parts technicians received the COR Cooling™ unit at our facility to exchange for another, as part of our service exchange program. To determine and understand the cause of the failure, H-E Parts technicians cut and removed a section of the core for further analysis. The condition of the core after only a short service period showed internal signs of severe corrosion and random pitting, indicating that it may have been exposed to stray current, resulting in premature wear, cracking and ultimately leading to the radiator failure.

Radiator analysis showing stray current damage

H-E parts liaised with site personnel to understand the condition of the radiator and it was discovered that the radiator failures were occurring on only one truck. After initial testing using a multimeter was conducted, an on-site investigation found the engine was missing an earth strap to the chassis. This was causing stray current to pass through the radiator, an issue which has been identified previously by H-E Parts technical subject matter experts (SME's).

H-E Parts identified the cause of the failures, preventing the customer from further downtime due to a third install. Since the installation of the new service exchange unit, the customer hasn't experienced any further failure or issues and the radiators are again meeting required service exchange intervals.

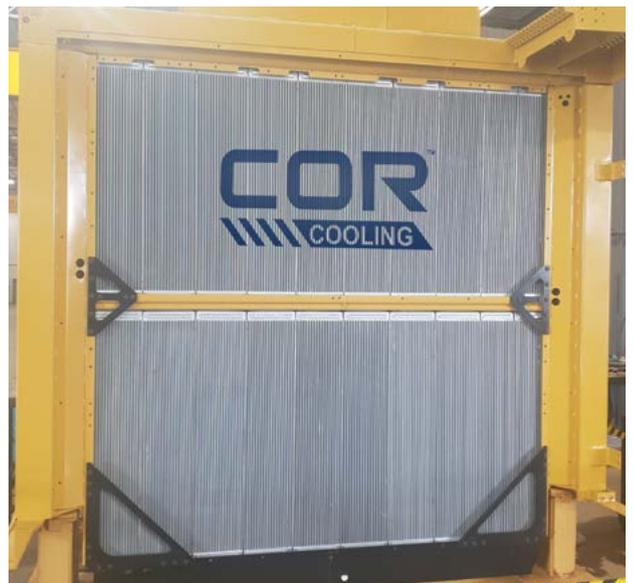
Newly supplied COR Cooling™ radiator
